#### B. Signature Analysis Setup Procedure

#### C. Signature Analysis Test #1 Procedure

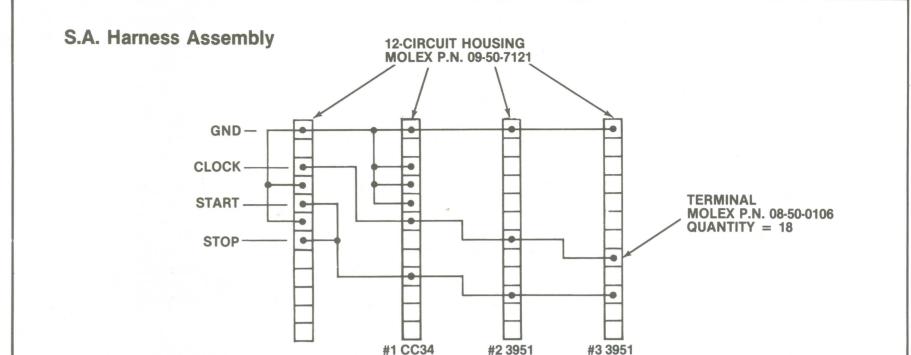
2. SA Harness Assembly:

Atari part number A036836-01. You can make one of these yourself. The following is an illustration of its construction.

- Plug SA Harness Assembly Test #1 connector onto Signal Analyzer header on Auxiliary PCB (the black wire on the connector should be at the top).
- Connect a jumper between PWR ON RESET test point and ground. This places a continuous RESET to the microprocessor on the Analog Vector-Generator PCB.
- . Set Signature Analyzer START to \_\_/\_, STOP to \_\_/\_, and CLOCK to\_\_/\_.
- Connect a jumper wire between the PU test point on the Auxiliary PCB and the tip of the Signature Analyzer probe.
- 5. The Signature Analyzer should indicate CC34.
- 6. Probe for signatures as shown in Figure 1 to the left. If all signatures are correct, continue with *D. Signature Analysis Test* #2A Procedure. If not **CC34**, refer to *G. Isolating a Failing Circuit*.

- Remove the jumper wire from Signature Analyzer probe.
- Plug SA Harness Assembly Test #2 connector onto Signature Analyzer header on Auxiliary PCB.
- Remove jumper from PWR ON RESET on the Analog Vector-Generator PCB.
- 4. Set Signature Analyzer START to \_\_/\_\_\_, STOP to \_\_\_\_\_\_, and CLOCK to \_\_/\_\_.
- Connect one end of the jumper wire to the ground test point on the Analog Vector-Generator PCB. Touch the DIAG 'STEP' test pad with the other end of the jumper wire five times. After the fifth time, the screen will be blank.
- 6. Verify that setup procedure is correct by probing +5V for a signature of **3951**.
- 7. Probe for signatures as shown in Figure #2A to the left. If all signatures are correct, continue with *E. Signature Analysis Test* #2B Procedure. If a signature is incorrect, refer to *G. Isolating a Failing Circuit*.
