Installation Instructions

OBA-2 BILL ACCEPTORS
KIT #27065101 KIT-OBA UPGRADE - NEW \$5 SINGLE BOARD
KIT #27065102 KIT-OBA UPGRADE - NEW \$5 DOUBLE BOARD,
CONTROL UNITS 45057501, 45057505
KIT #27065104 KIT-OBA UPGRADE - NEW \$5 DOUBLE BOARD,
CONTROL UNITS 45057502, 03, 12

To upgrade the software in the control unit to allow the bill acceptor to accept the new \$5 Bill.

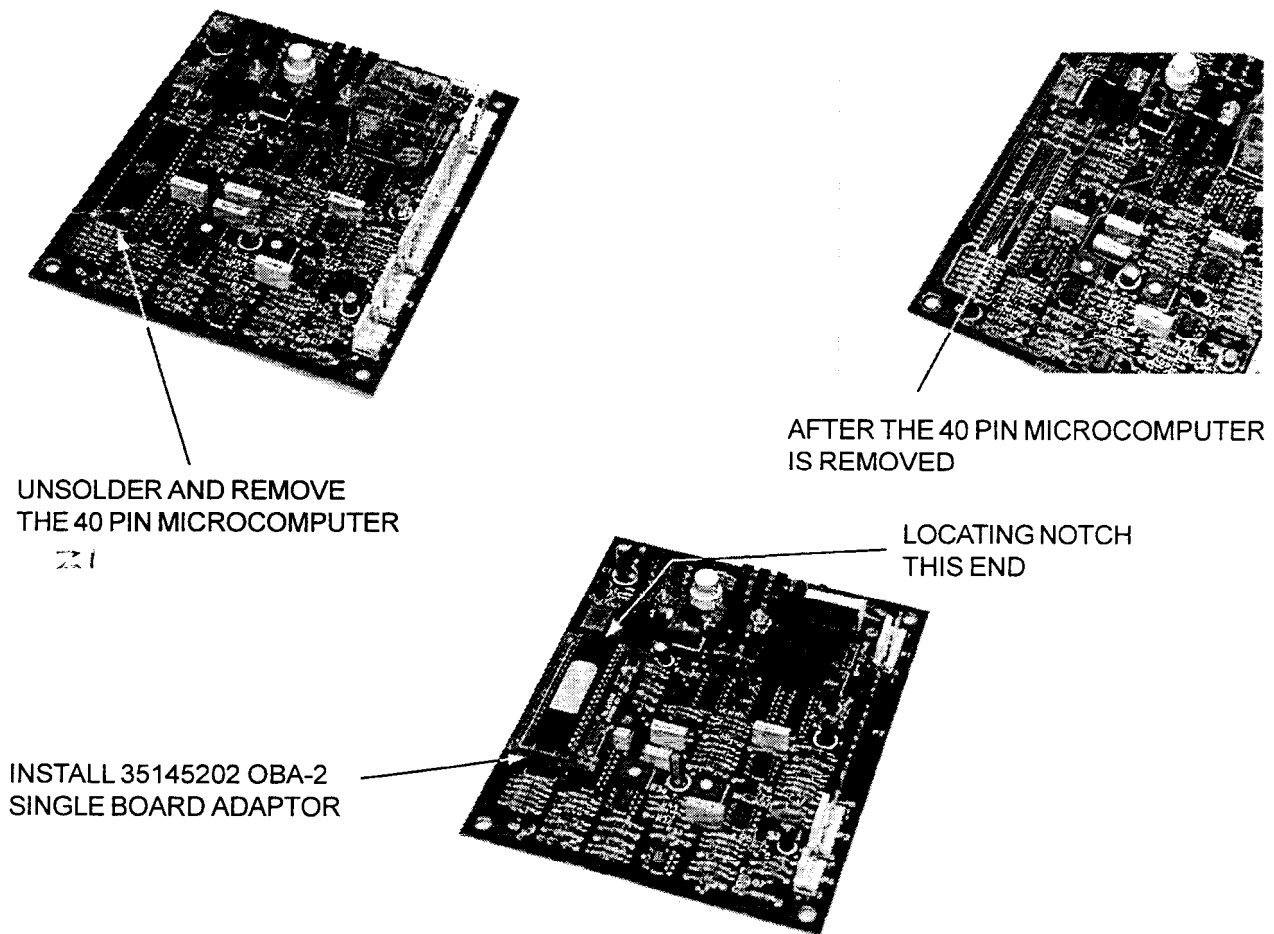
FIGURE 1

1. Remove cover from control unit. This old cover will not be reused.
2. Remove the circuit board assembly from the base.
3. Locate, unsolder, and remove the 40-pin microcomputer from the board. See *Figure 1*.
4. Install the new #35145202 OBA-2 adaptor board onto the circuit board where the microcomputer was removed. Be sure that the locating notch on the end of the new microcomputer lines up with the locating notch on the printing on the circuit board. See *Figure 1*. Solder the adaptor in place.
5. Apply the Part Number Label over the old part number on the circuit board. Install the circuit board in the base. Install the new cover assembly on the control unit.
6. Connect the control unit to the OBA-2 transport and test.

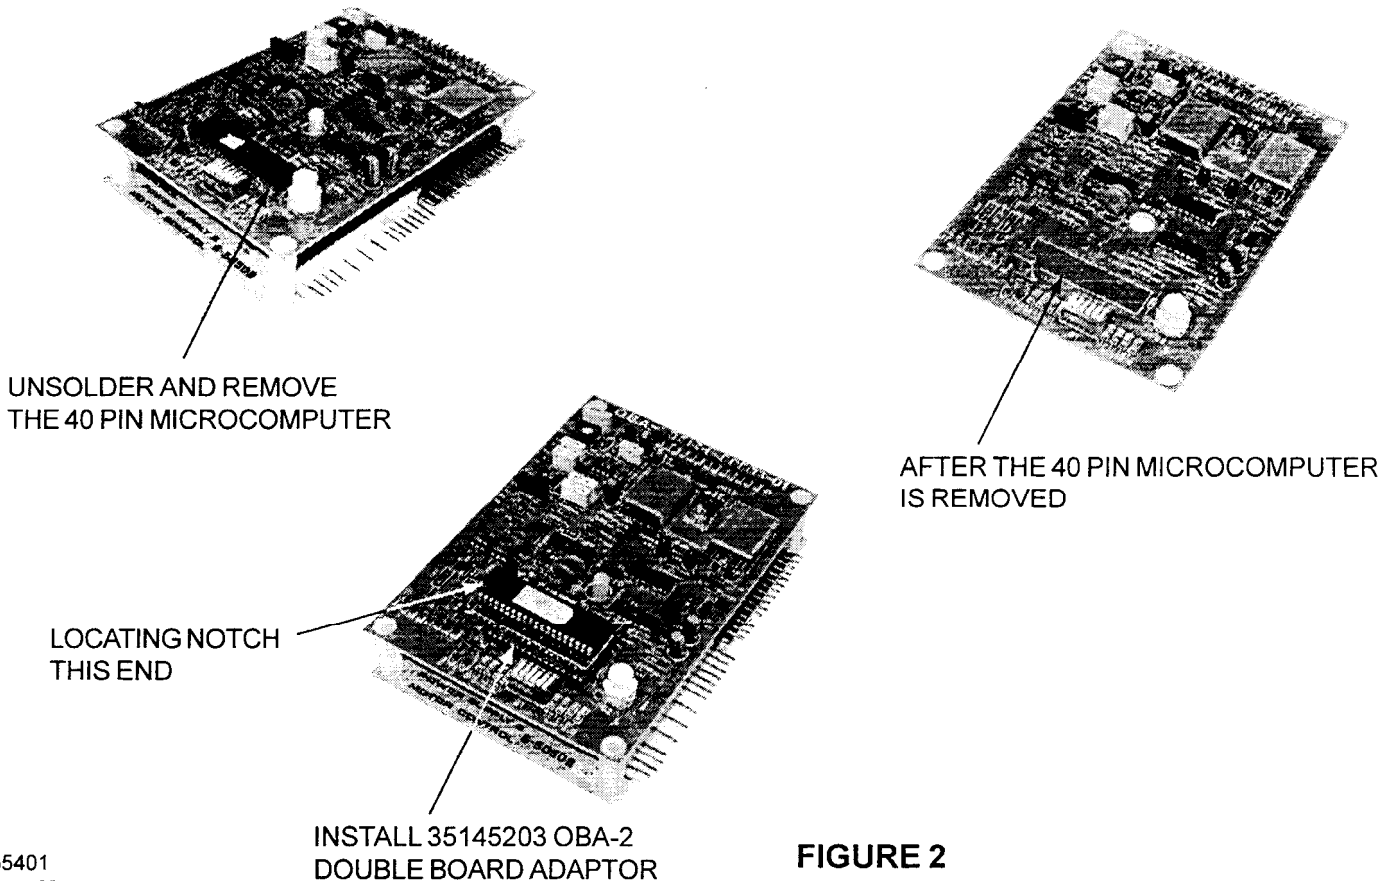
FIGURE 2

1. Remove cover from control unit. This cover will not be reused.
2. Unplug connectors and remove circuit boards from base.
3. Separate the upper Logic Board from the lower Power Supply Board.
4. Locate, unsolder, and remove the 40-pin microcomputer from the Logic Board. *See Figure 2.*
5. Install the new 35145203 OBA-2 adaptor board onto the Logic Board where the microcomputer was removed. Be sure that the locating notch on the end of the new microcomputer lines up with the locating notch on the printing on the circuit board. *See Figure 2.* Solder the adaptor in place.
6. Apply the Part Number Label over the old part number on the circuit board. Reconnect the logic board to the Power Supply Board using the same spacers in the corners. Install the board assembly into the base and plug in the connectors. Install the new cover assembly onto the control unit.
